**FORD:**  
2003-2005 Excursion

2003-2007 F-Super Duty  
2004-2007 E-350, E-450

# TSB 07-1-4 (Continued)

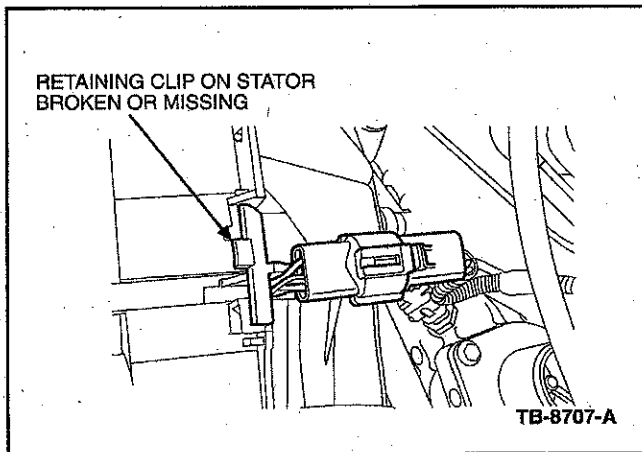
Figure 1 - Article 07-1-4

Some 2004-2007 E-Series 350/450, 2003-2005 Excursion, and 2003-2007 F-Super Duty vehicles, equipped with the 6.0L diesel engine, may exhibit improper engine cooling fan clutch operation due to its wire harness being cut by the rotating cooling fan.

1. A cut wire harness will prevent proper fan clutch operation. The harness may be cut because the molded-in retaining clip on the fan stator that secures the harness to the stator is broken or missing, allowing the loose harness to move into the rotating fan (Figure 1). If the harness is damaged or severed, replace the Cooling Fan Clutch Assembly per the Work Shop Manual, Section 303-03.

If the stator retaining clip is broken or missing, use the following procedure to secure the wire harness to the fan stator.
